AVON TOWN HALL

Facility Assessment and Space Needs Analysis
July 12, 2015

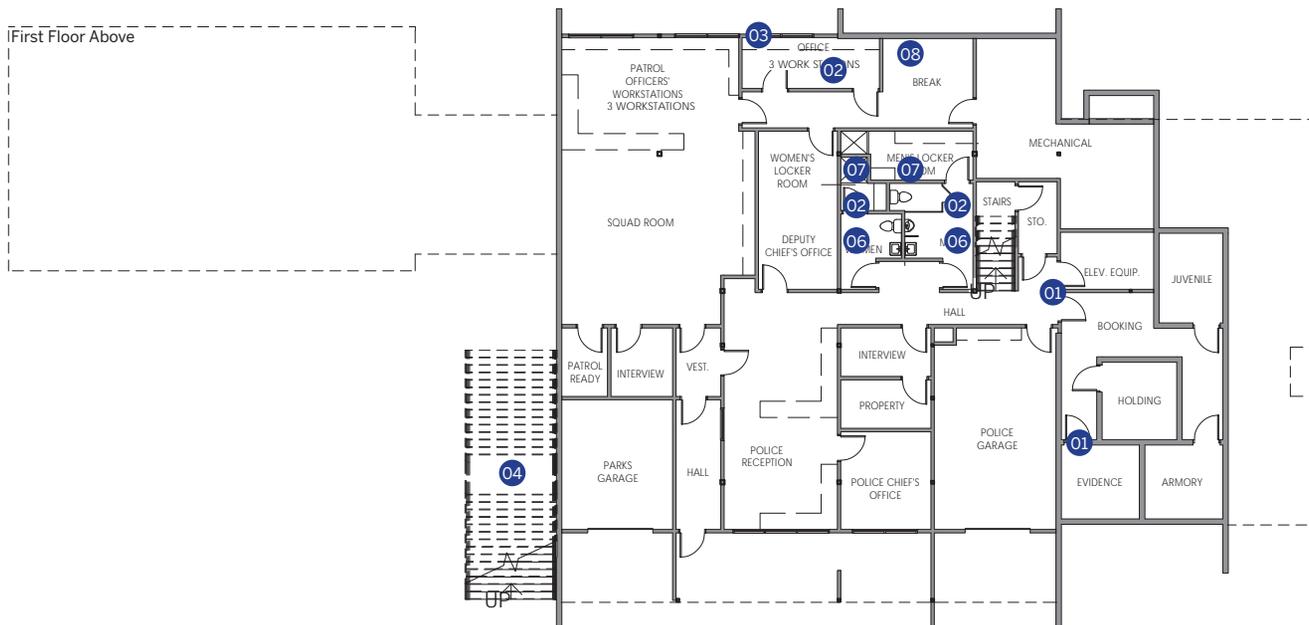
Basement Floor Plan

- 01 Non-accessible door - Inadequate ADA clearances per ANSI 117.1, 404.2.3.2
- 02 Non-accessible space - Inadequate turn around space per ANSI 117.1, 304

- 03 Typical - Inadequate quality daylight and view. The majority of windows are undersized and above head level. Latching hardware broken on numerous windows and prevent proper shutting. Integral blinds are inoperable between panes of glass

- 04 Non-compliant handrails:
 1. Inadequate handrail top and bottom extension per International Building Code
 2. Non-compliant gripping surface per ANSI 117.1, 505.6

- 05 Non-compliant egress door - Egress door is to swing in the direction of egress travel
- 06 Non-compliant restroom:
 1. Non-accessible stall - inadequate ADA clearance per ANSI 117.1, 604.8

3. Various non-compliant mounting height requirements for fixtures and accessories
- 07 Non-accessible shower and locker room:
 1. Non-accessible shower compartment provided - Inadequate clearances and lack of grab bars per ANSI 117.1, 608

2. Non-accessible locker space - Inadequate turn around space per ANSI 117.1, 304
 3. Accessible locker bench is not provided and lack of aisle space for adequate accessible bench

- 08 Non-accessible counter height
- 09 Inadequate sound enclosure. Space gets very noisy from events on first floor
- 10 Leaks and water damages were observed on the ceiling from the skylight above to the office below

- 11 Typical - Non-compliant exterior sheathing, insulation, and vapor barrier to meet current code

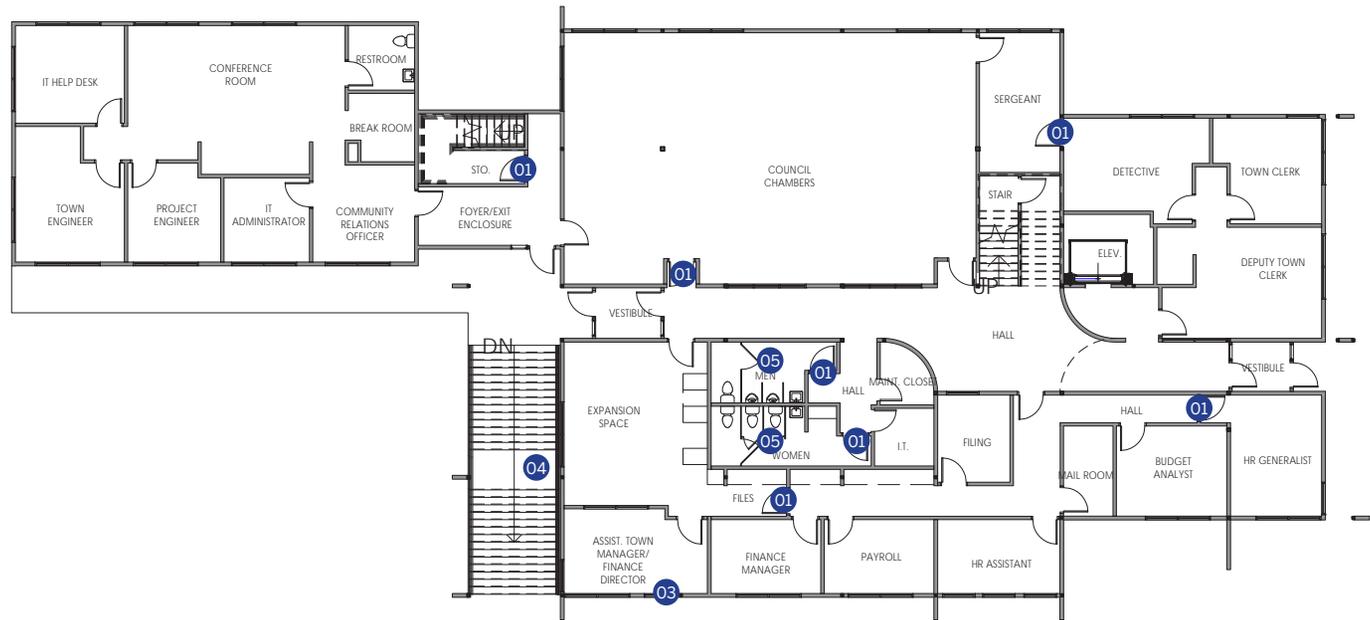
First Floor Plan

- 01 Non-accessible door - Inadequate ADA clearances per ANSI 117.1, 404.2.3.2
- 02 Non-accessible space - Inadequate turn around space per ANSI 117.1, 304

- 03 Typical - Inadequate quality daylight and view. The majority of windows are undersized and above head level. Latching hardware broken on numerous windows and prevent proper shutting. Integral blinds are inoperable between panes of glass

- 04 Non-compliant handrails:
 1. Inadequate handrail top and bottom extension per International Building Code
 2. Non-compliant gripping surface per ANSI 117.1, 505.6

- 05 Non-compliant restroom:
 1. Non-accessible stall - inadequate ADA clearance per ANSI 117.1, 604.8
 2. Exposed piping - Water supply and drainpipes under lavatories shall be insulated or otherwise configured to protect against contact per ANSI 117.1, 606.6

3. Various non-compliant mounting height requirements for fixtures and accessories
- 06 Non-accessible shower and locker room:
 1. Non-accessible shower compartment provided - Inadequate clearances and lack of grab bars per ANSI 117.1, 608

- 08 Non-accessible counter height
- 09 Inadequate sound enclosure. Space gets very noisy from events on first floor
- 10 Leaks and water damages were observed on the ceiling from the skylight above to the office below

- 11 Typical - Non-compliant exterior sheathing, insulation, and vapor barrier to meet current code

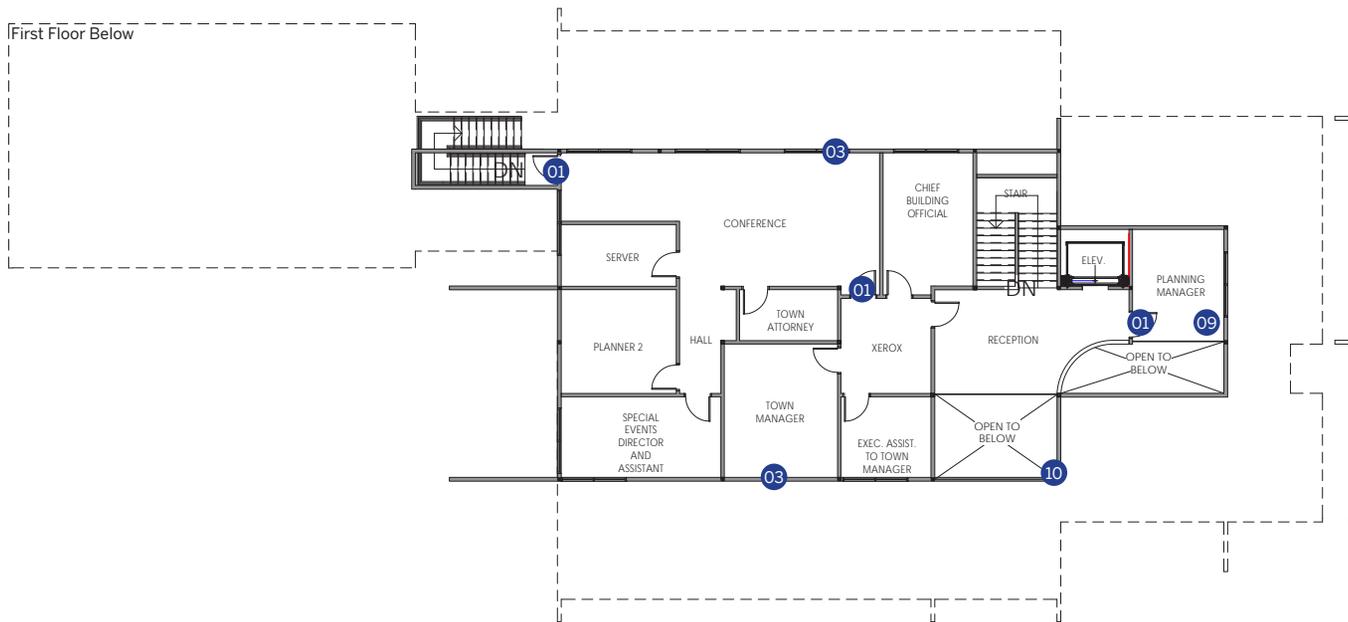
Second Floor Plan

- 08 Non-accessible counter height
- 09 Inadequate sound enclosure. Space gets very noisy from events on first floor
- 10 Leaks and water damages were observed on the ceiling from the skylight above to the office below. Remove and replace skylight window with new construction

- 11 Typical - Non-compliant exterior sheathing, insulation, and vapor barrier to meet current code

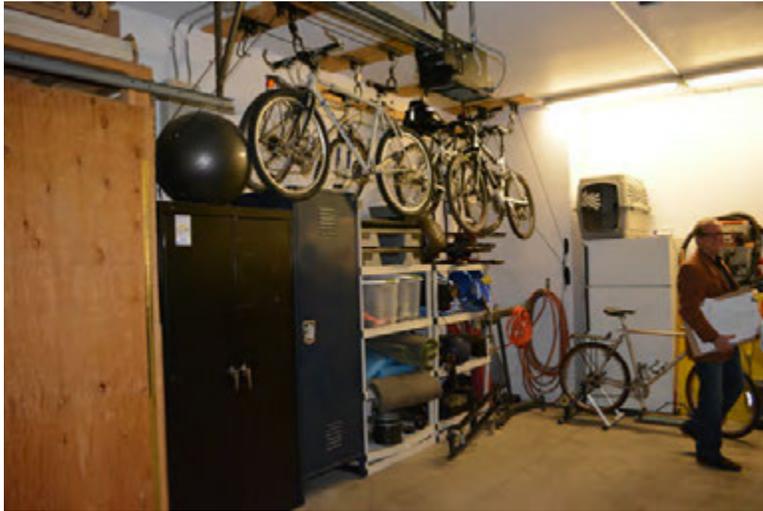
Police Sallyport - Inadequate security, police sallyport also being used as storage and exercise room. Items potentially can be used against police officers during prisoner transport.

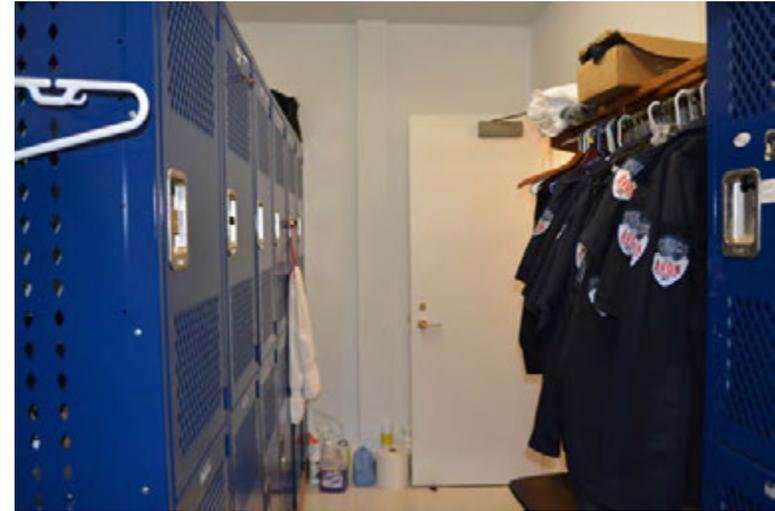
Non-accessible shower and locker room:

1. Non-accessible locker space - Inadequate turn around space per ANSI 117.1, 304
2. Accessible locker bench is not provided and lack of aisle space for adequate accessible bench

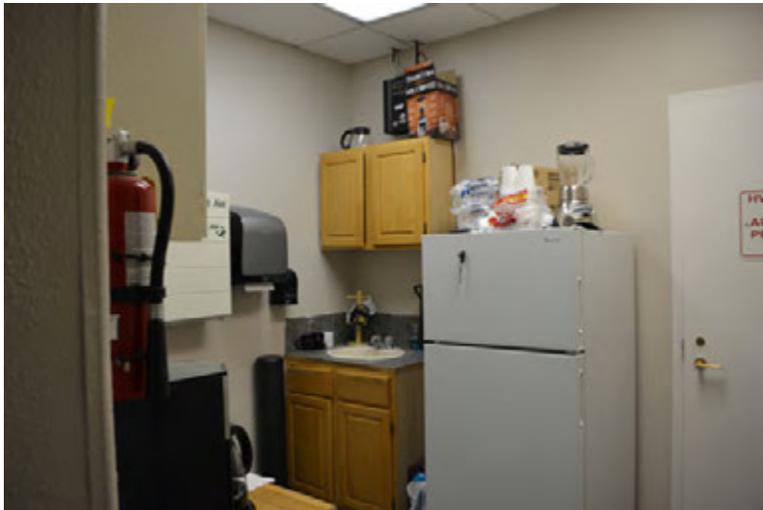
Non-accessible counter height

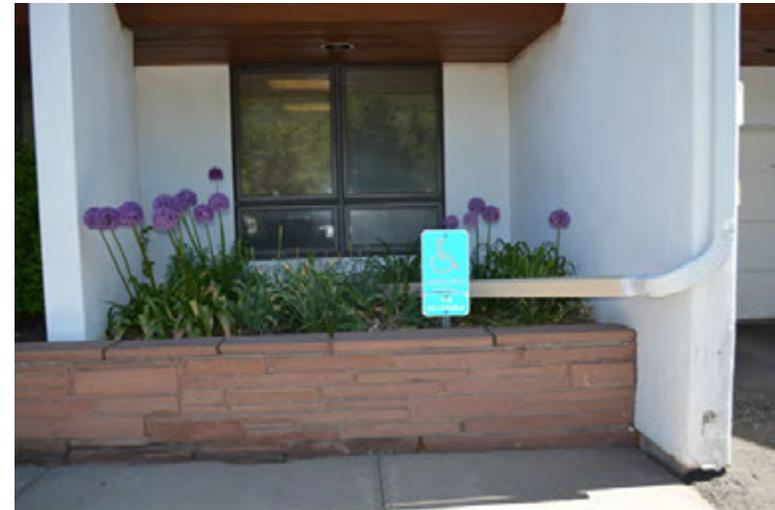
Inadequate roof drainage, roof drain is being directed back into a planter because of drainage problem on site

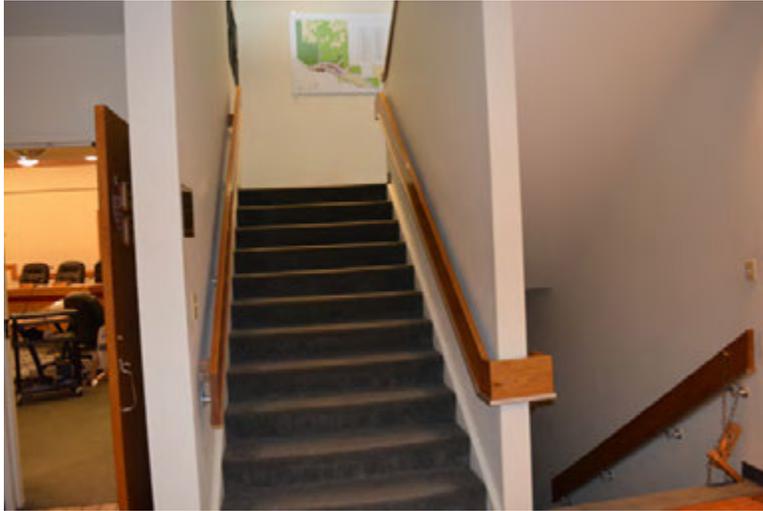
Non-compliant handrails - Inadequate handrail top and bottom extension per International Building Code

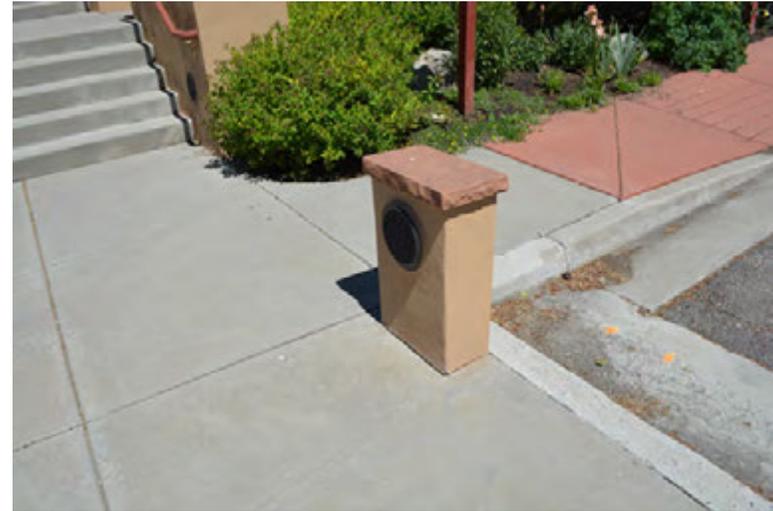
Light bollards - inadequate structure, bollards are completely detached from sidewalk.

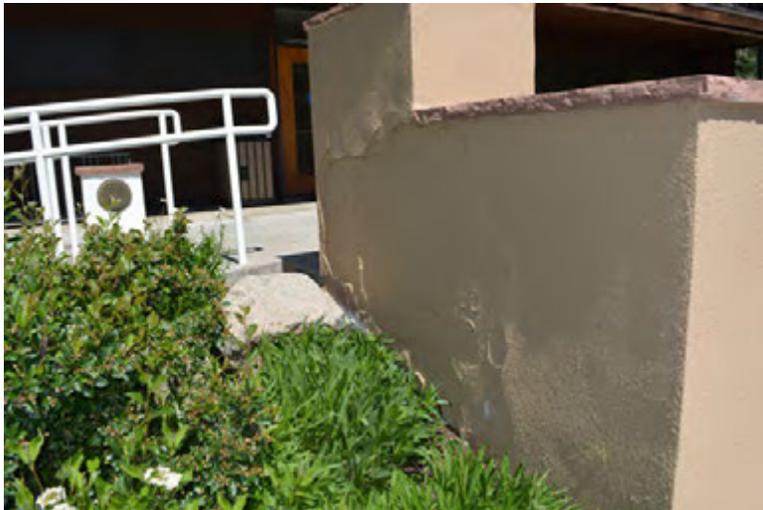
Damage to exterior stucco finishes around building entrance

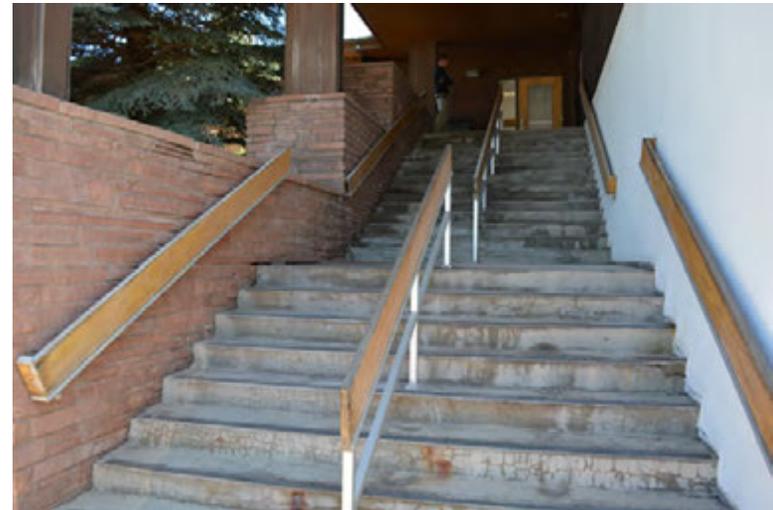
Non-compliant handrails:
1. Inadequate handrail top and bottom extension per International Building Code
2. Non-compliant gripping surface per ANSI 117.1, 505.6

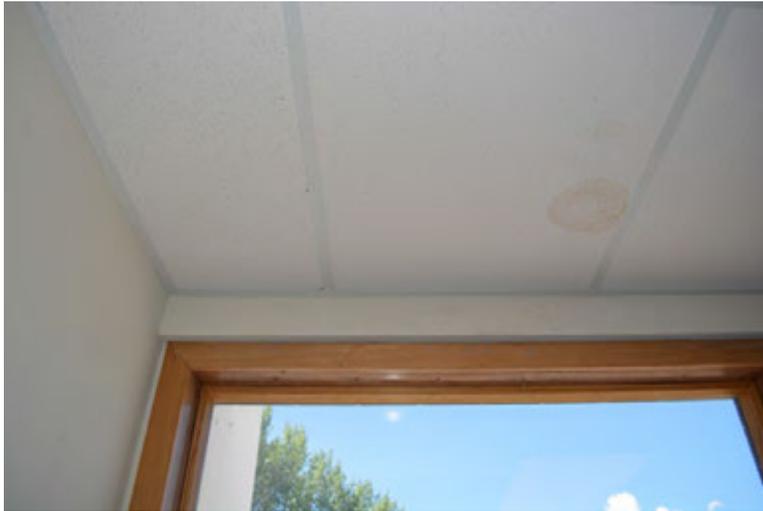
The overall building structure is performing well and is in good condition. One area that has been identified as a maintenance issue is the sloped glazing that is regularly leaking. The existing skylight opening is approximately 20' x 6'-6" and the opening is framed out with edge steel beams. If the skylight is to be eliminated in the future, the roof can be infilled with light steel framing and 1-1/2" steel roof deck.

Leaks and water damages were observed from the skylight above to the office below

The leaks and the exterior finishes should be repaired as required to maintain water proofing. It appears that the ceiling in the atrium area was installed with slack in the suspension rod system. In order to cosmetically improve the ceiling, it is recommended to adjust the tension rods as required to level the ceiling tiles.

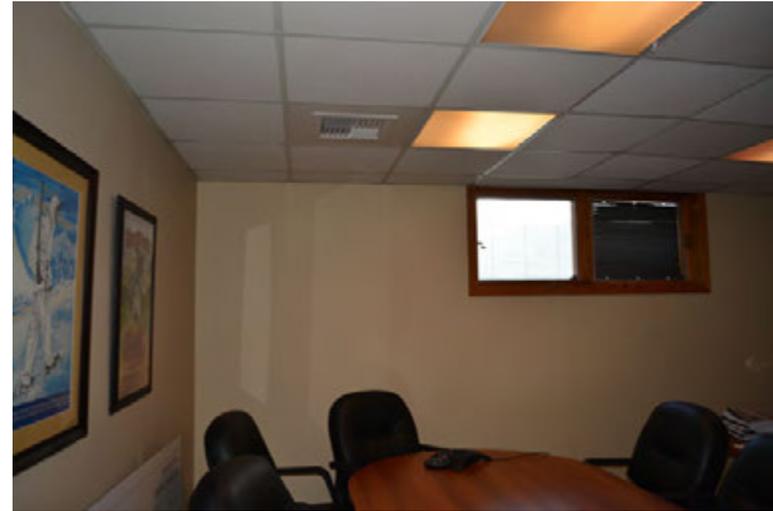
Inadequate quality daylight and view. Windows are undersized and above head level

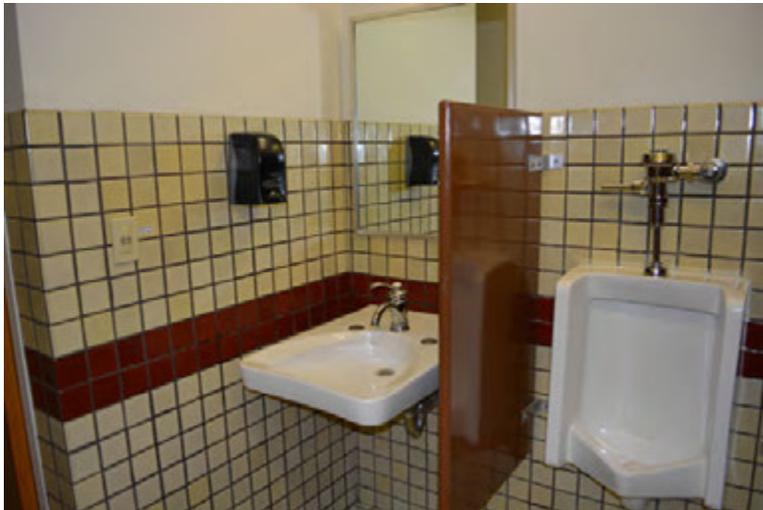
Exposed piping - Water supply and drainpipes under laboratories shall be insulated or otherwise configured to protect against contact per ANSI 117.1, 606.6

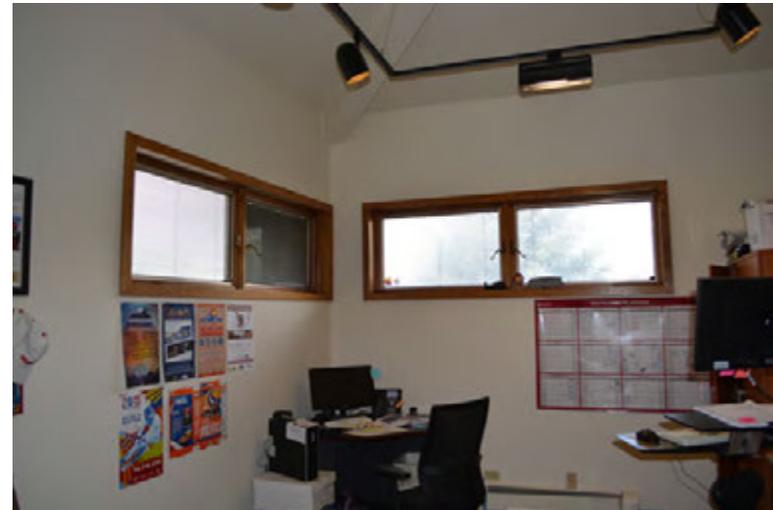
Inadequate quality daylight and view. Windows are undersized and above head level

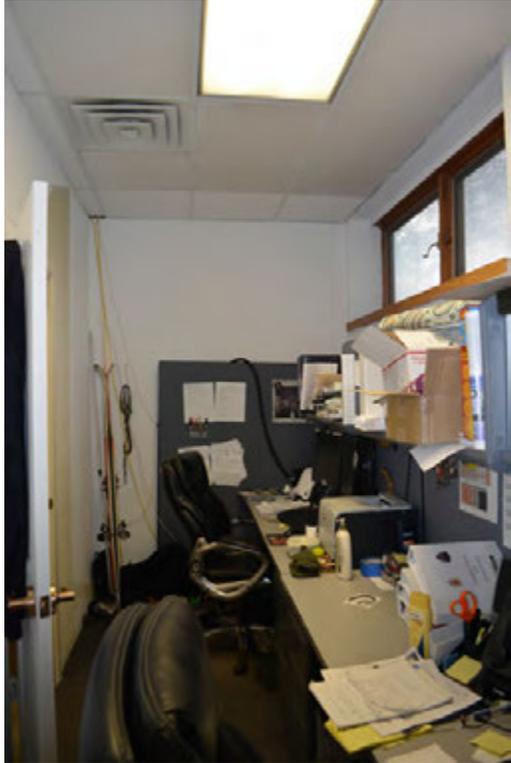
Non-accessible space - Inadequate turn around space per ANSI 117.1, 304

Inadequate quality daylight and view. Windows are undersized and above head level

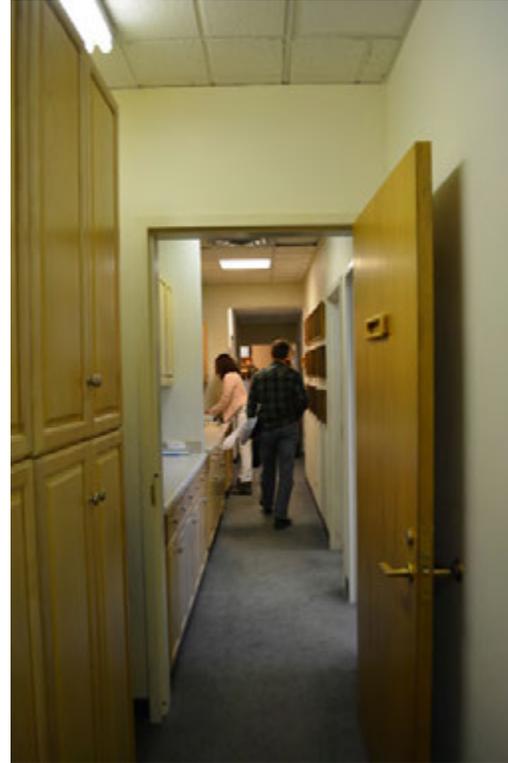
Non-accessible door - Inadequate ADA clearances per ANSI 117.1, 404.2.3.2

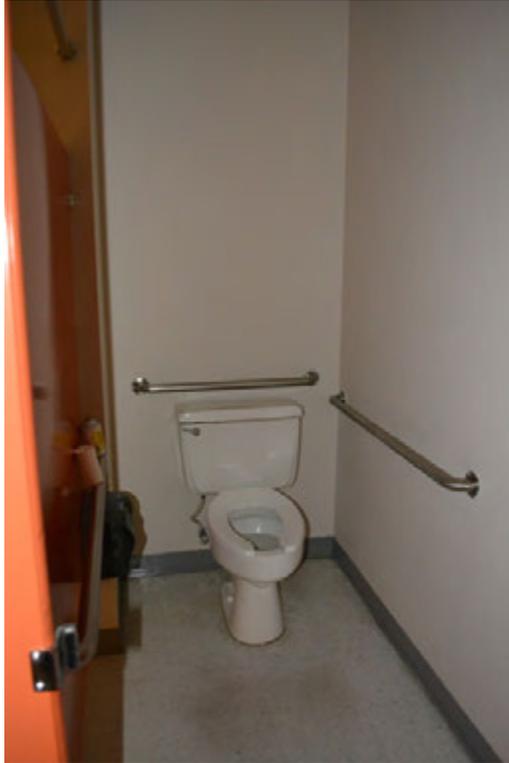
Non-accessible stall - Inadequate ADA clearances per ANSI 117.1, 604.8

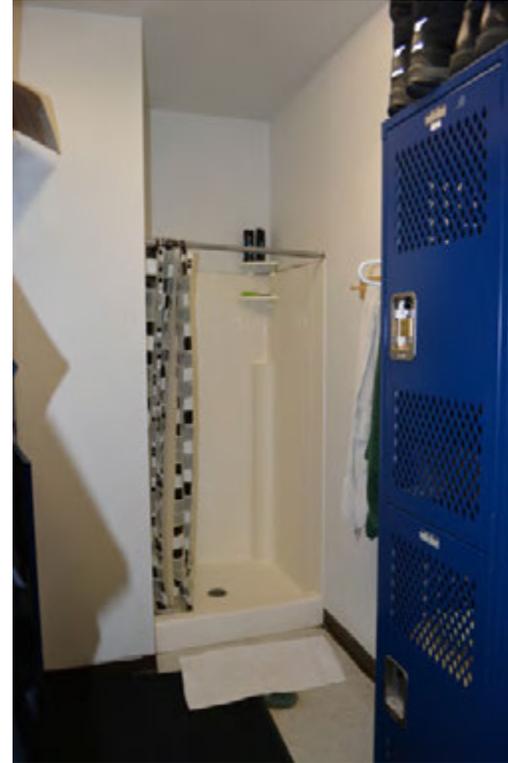
Non-accessible shower compartment provided - Inadequate clearances and lack of grab bars per ANSI 117.1, 608

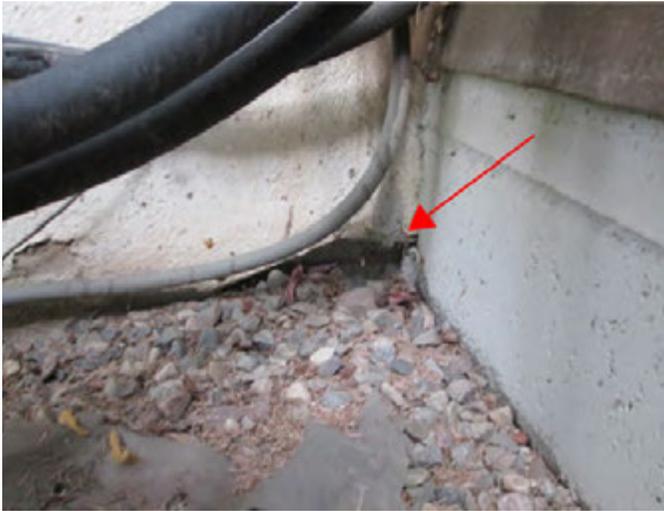
Damage on Exterior insulation and finishing system (EIFS)

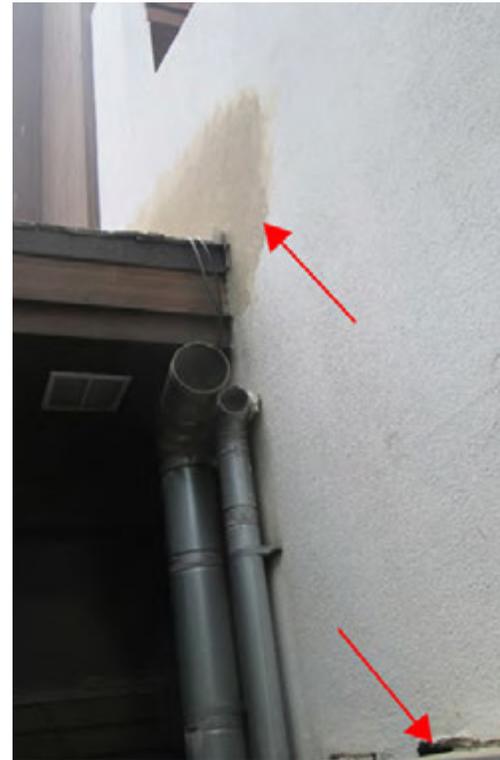
Repairs have been performed on some areas where the damage on Exterior insulation and finishing system (EIFS) was observed. Non-compliant color/finish was used as shown on picture.

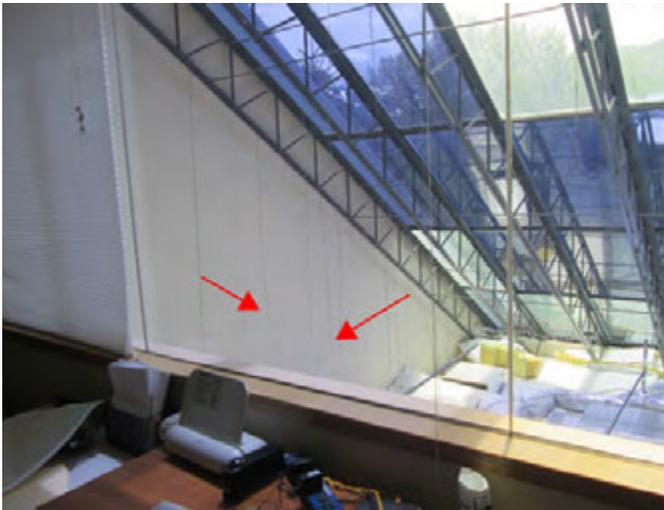
- Ceiling grid rods was installed with slacks
- Southeast corner of atrium skylight leaks and causes damage on the ceiling below.

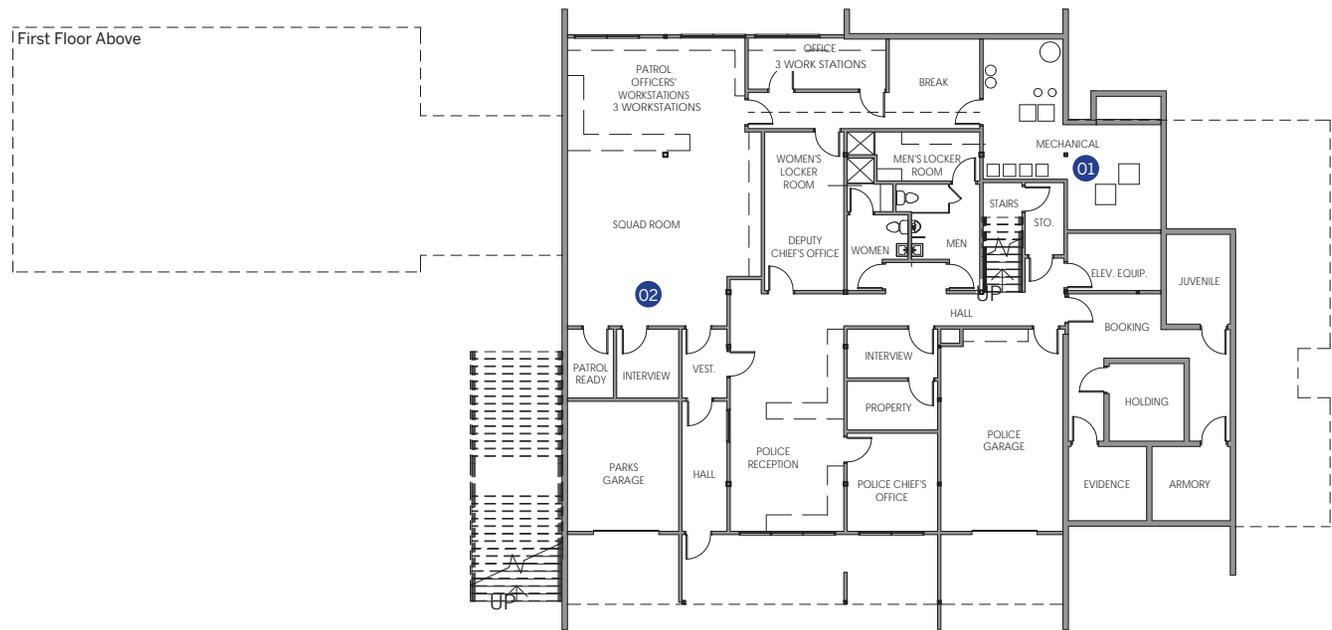
Basement Floor Plan

- 01 Mechanical room containing potable hot water heater, two heating hot water pumps, glycol storage, four variable frequency drives, two boilers, and two fans.
 1. Potable hot water heater- 82 gallons, manufactured in 2004, 80% efficient
 2. Heating hot water pumps- missing tag, older pumps, leaks
 3. Boilers- manufactured in 2006 outside the U.S., 85% efficient
 4. Fans- manufactured by Barry Blower
- 02 Supplemental unit for the squad room.

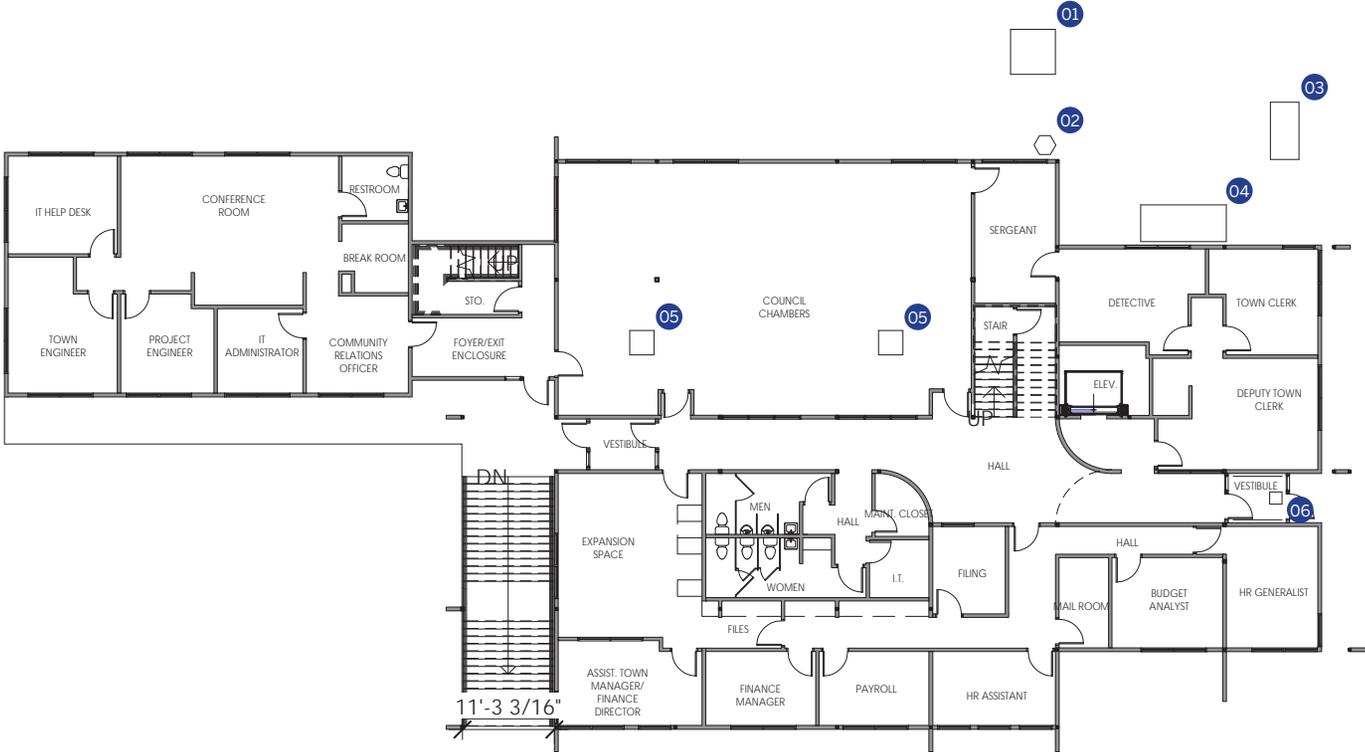
First Floor Plan

- 01 Air cooled chiller- Trane, manufactured in 1995.
- 02 Natural gas service into the building with regulator.
- 03 Lochinvar boiler for snowmelt system.
- 04 Snowmelt pumps and valves.
- 05 Fan Coil units for zoning. Multiple units throughout the building.
- 06 Fin tube heat at the floor.

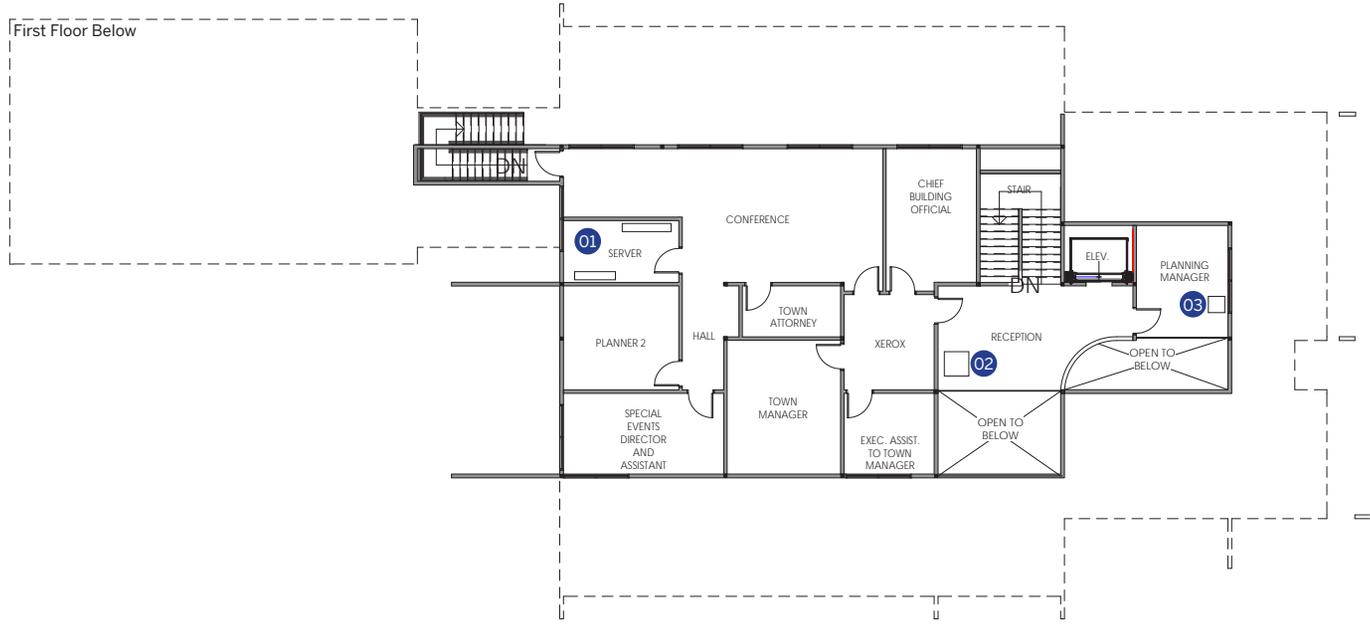
Second Floor Plan

- 01 Stand-alone wall-mounted split-system air conditioning.
- 02 Fan Coil unit.
- 03 Window unit.

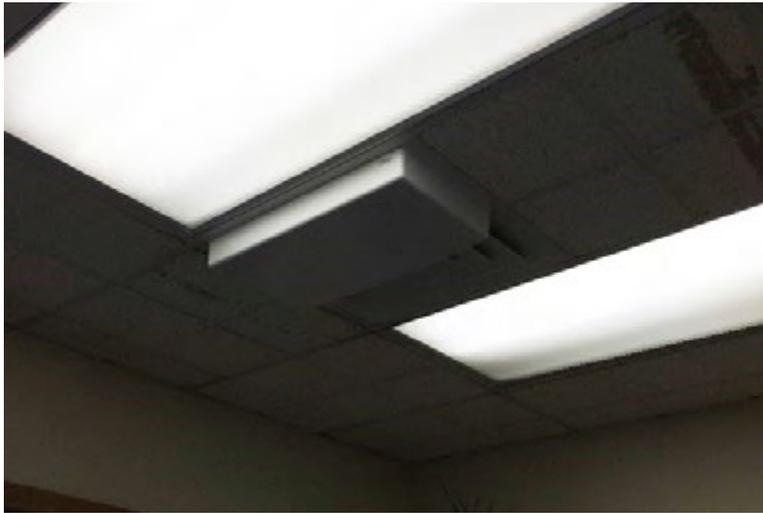
Homemade deflector for comfort

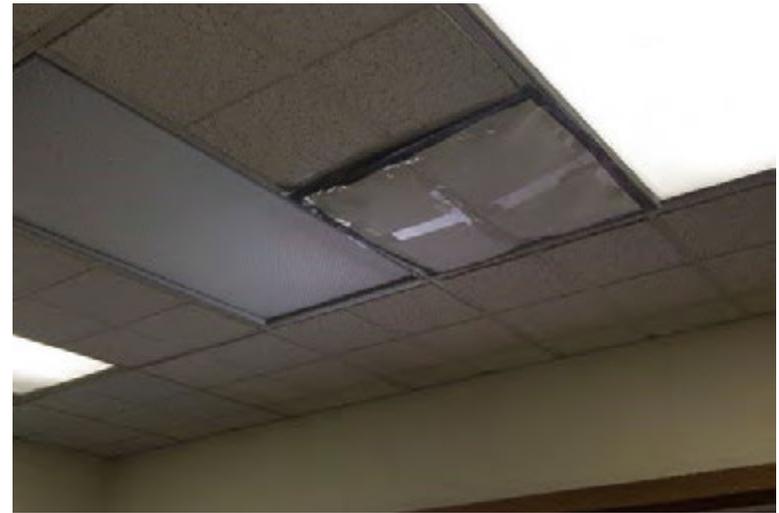
Homemade deflector for comfort

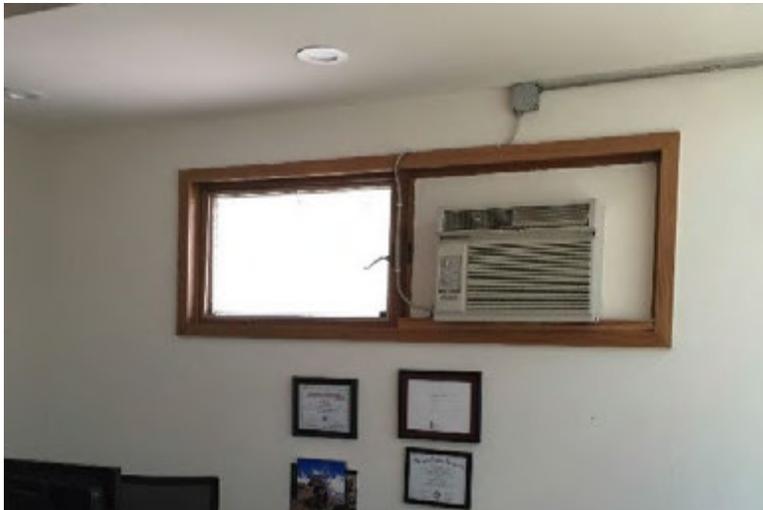
Added unit for comfort

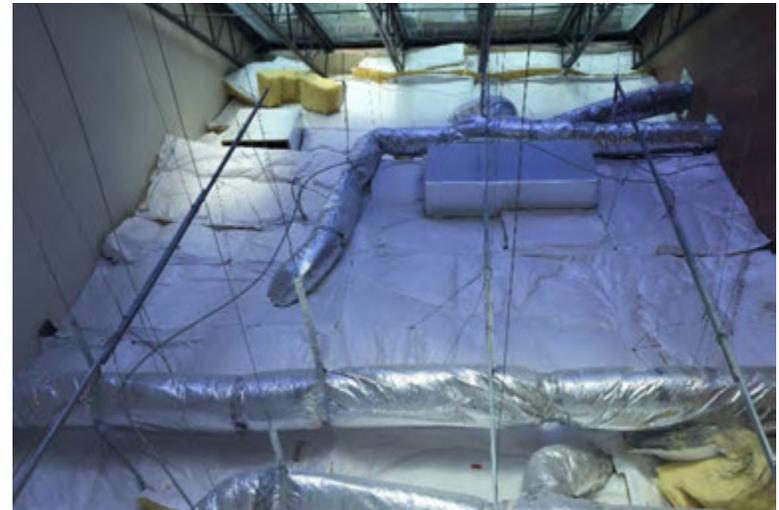
Added capacity to the main equipment

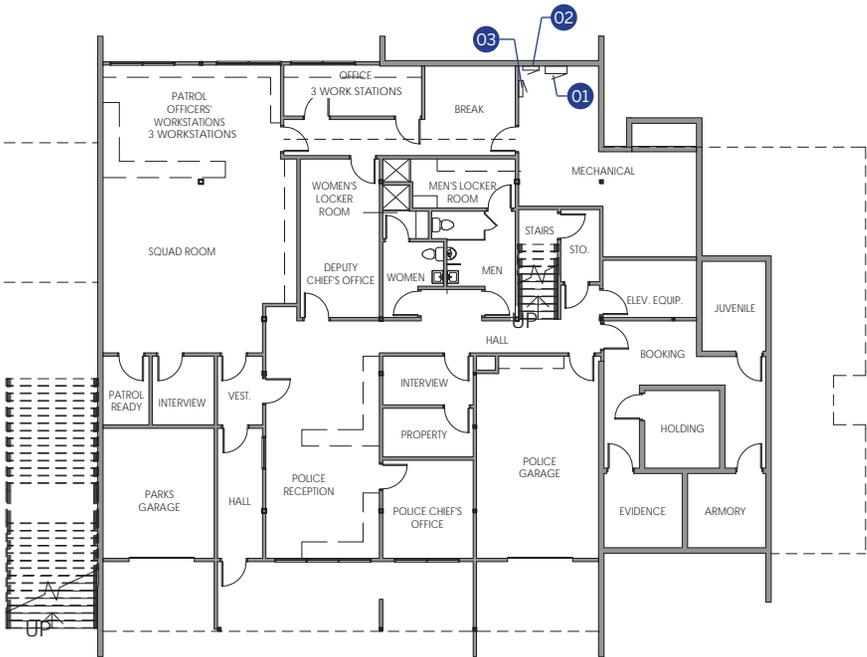
Basement Floor Plan

- 01 Main Distribution Panel; 600 A, 208 volt, 3-phase. Good condition – Recommend replacement
- 02 Panel 'LP1' – 225 amp, 208 volt, 3-phase. Fair condition – Recommend replacement – Fed from 'MDP' with 100 amp feed.
- 03 Panel 'LP4' – 100 amp, 208 volt, 3-phase. Fair condition – Recommend replacement – Fed from 'MDP' with 100 amp feed.

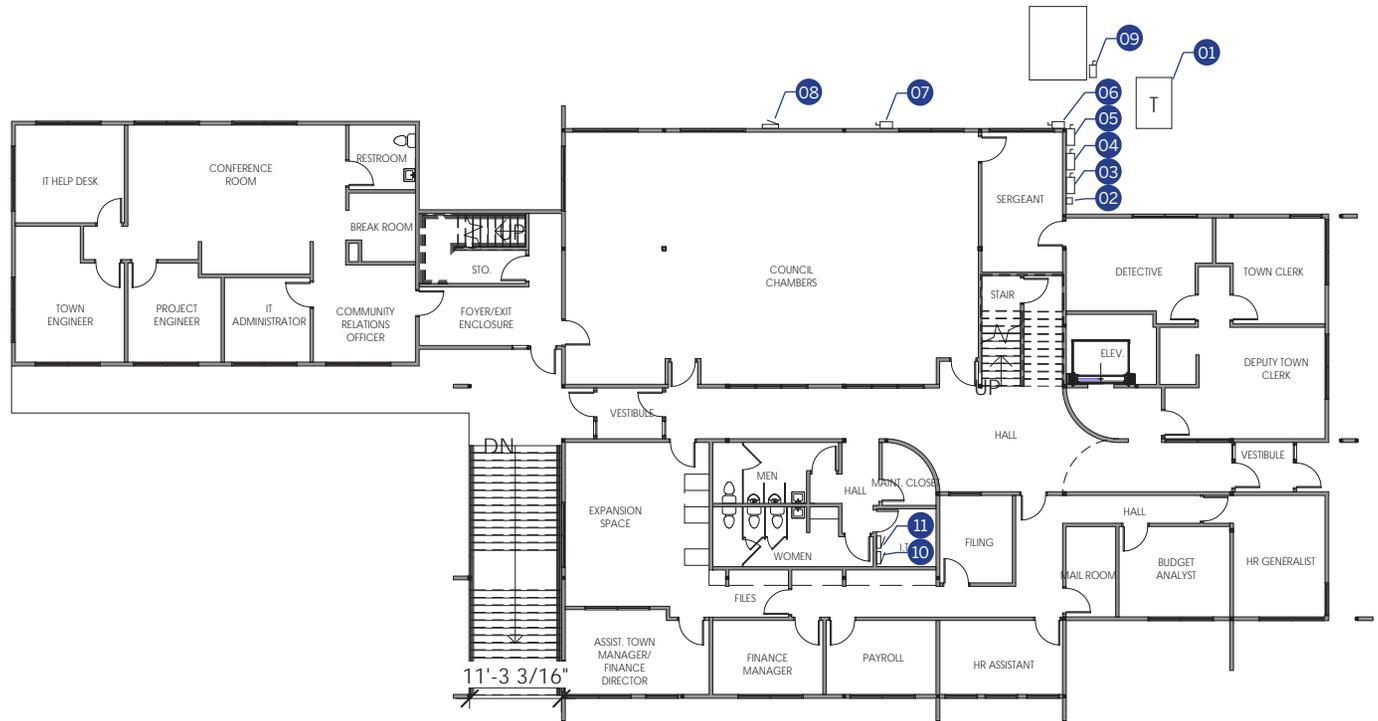
First Floor Plan

- 09 Chiller Disconnect: 400 amp, 3-phase Poor condition -Recommend replacement – Fed from utility transformer.
- 10 Panel 'LP2': 225 amp, 208 volt, 3-phase, Fair condition - Fed from 'MDP' with 200 amp feed.

- 11 Panel 'LP2A': 100 amp, 208 volt, 3-phase, Fair condition - Fed from panel 'L2' with 100 amp feed.

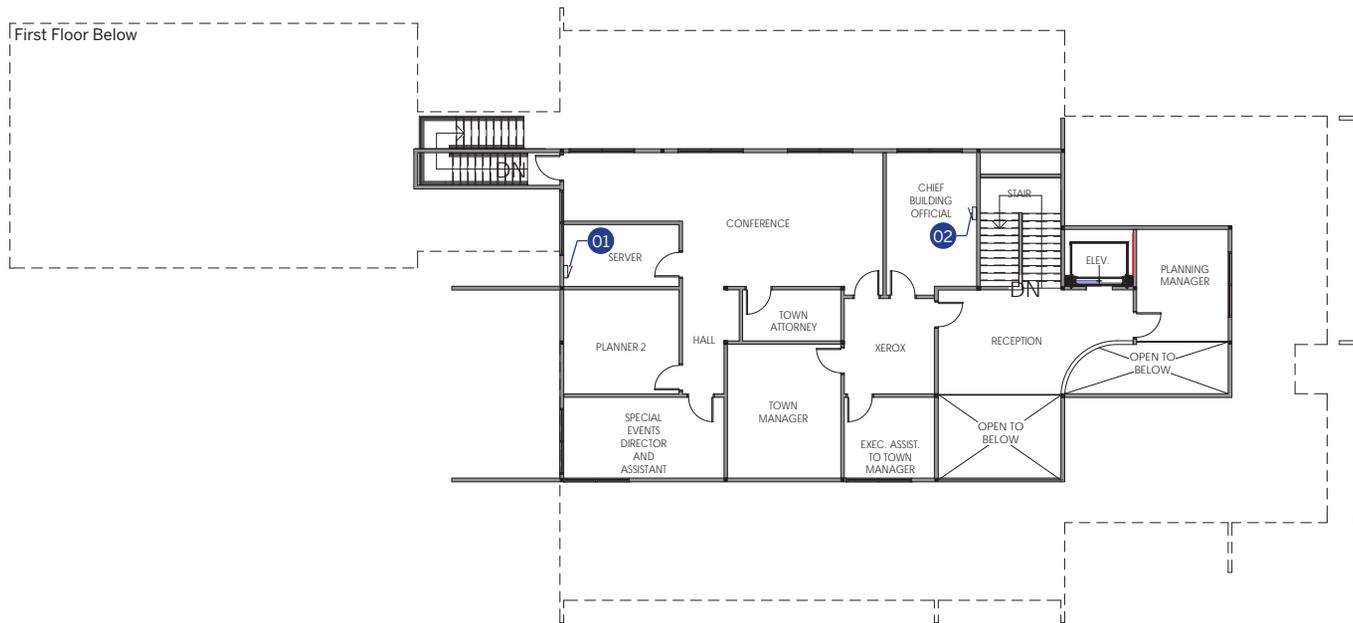
Second Floor Plan

- 01 Panel 'LP5': Current rating not indicated (Assume 200 amp), 208 volt, 3-phase, Fair condition - Recommend replacement - Fed from 'MDP' with 150 amp feed.
- 02 Panel 'LP3': 100 amp, 208 volt, 3-phase, Fair condition - Recommend replacement - Fed from 'MDP' with 100 amp feed.

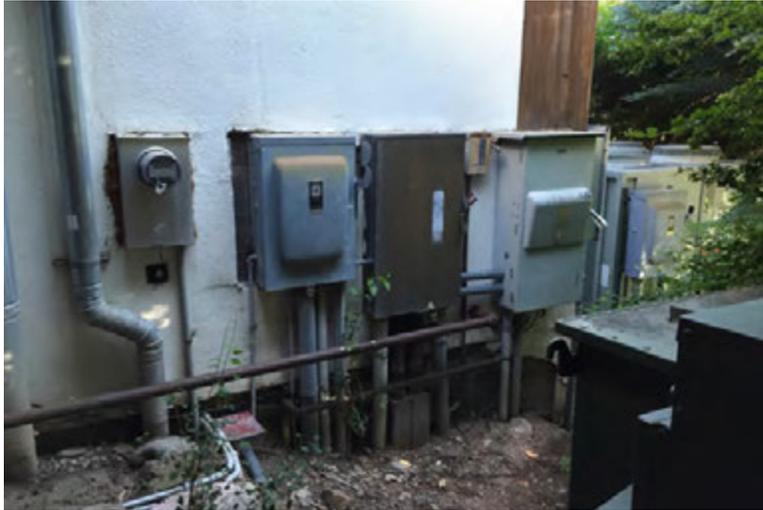
Multiple aging electrical services / disconnects at building exterior
