**Town of Avon  
Recreational Trails Master Plan  
February 2009**

**Anasazi Trails, Inc.  
9 South Arroyo Road  
Madrid, New Mexico 87010**

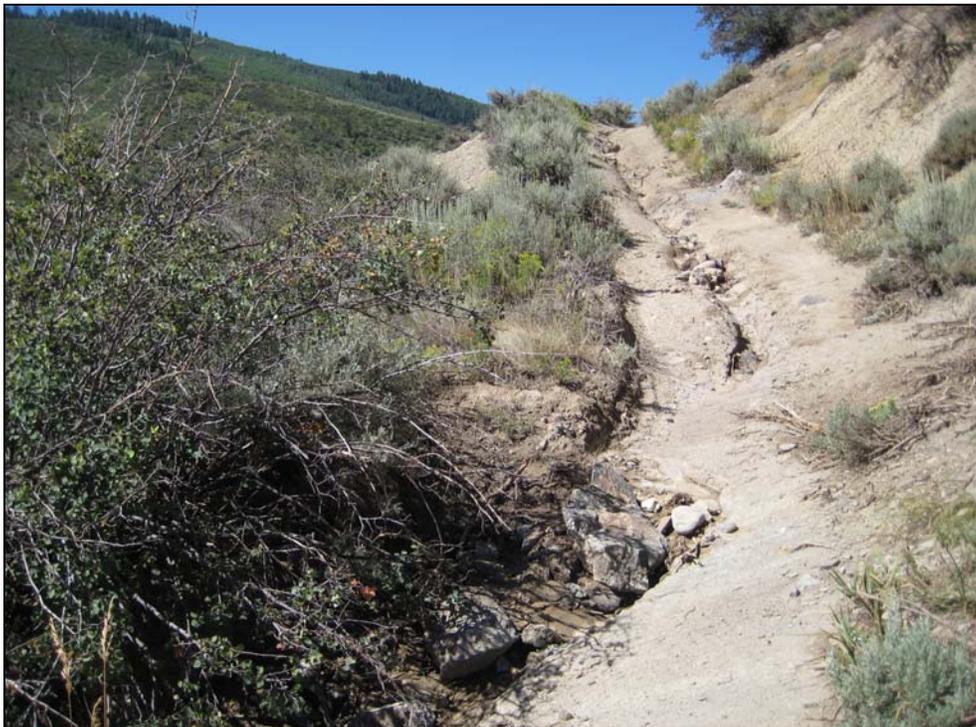
Looking east at an eroded and washed out section of the Avon/Singletree Trail

This existing trail primarily runs east to west and connects Avon to the Singletree Subdivision. As seen in the accompanying photographs, a significant portion of the trail is aligned along what appears to be an old utility service road. The trail is open to pedestrian, equestrian, and mountain bicycle users between April 16<sup>th</sup> and December 14<sup>th</sup> and closed to all uses during the winter from December 15<sup>th</sup> to April 15<sup>th</sup>. An area adjacent to the trail is referred to as “Motorcycle Flats” and is located south and west of the trail’s junction with the Saddle Ridge Trail. Motorized use is prohibited at anytime in this area or on the trail. Approximately one-quarter mile section of the west end of the trail is within the Singletree Subdivision boundary. Overall, the trail is in fair to poor condition and lacks adequate signage. A single trailhead sign was observed at the June Creek access point in the Singletree Subdivision. An assessment of the trail revealed the majority of it is not in sustainable condition. The following photographs reveal many sections that are badly eroded, most of which fall along the utility service road. The trail is difficult to navigate on foot or by mountain bicycle as it is steep, rocky and rutted out in places. Several sections have washed out areas within the length of the trail’s tread. When attempting to access this trail from Nottingham Road, it is not obvious as trail signage is absent.

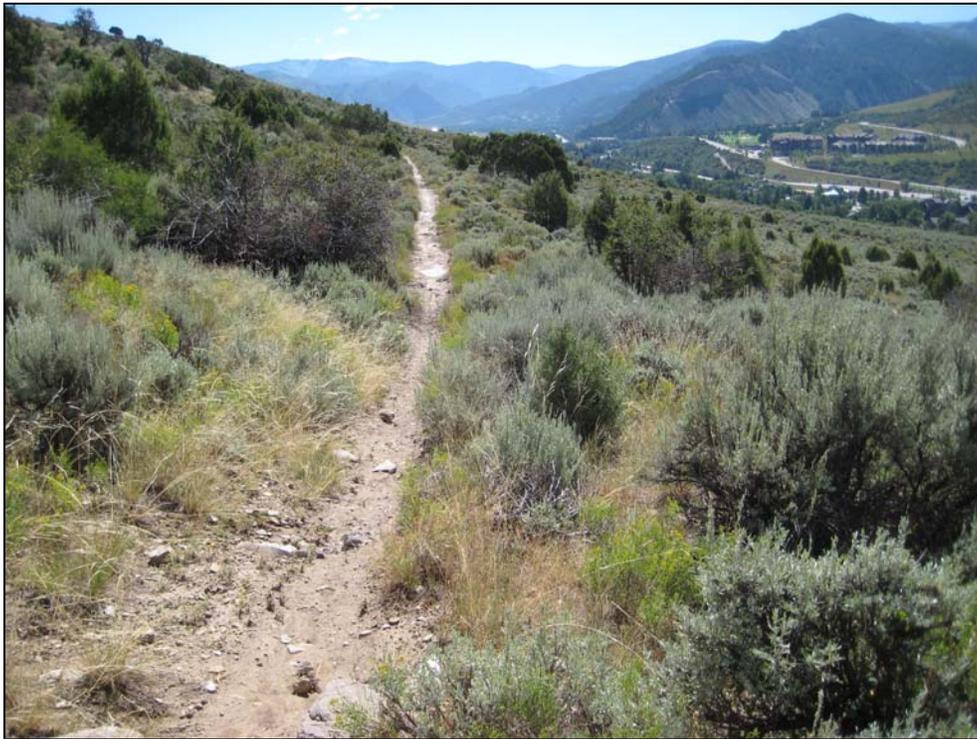
Looking east at one of the more sustainable sections of the trail

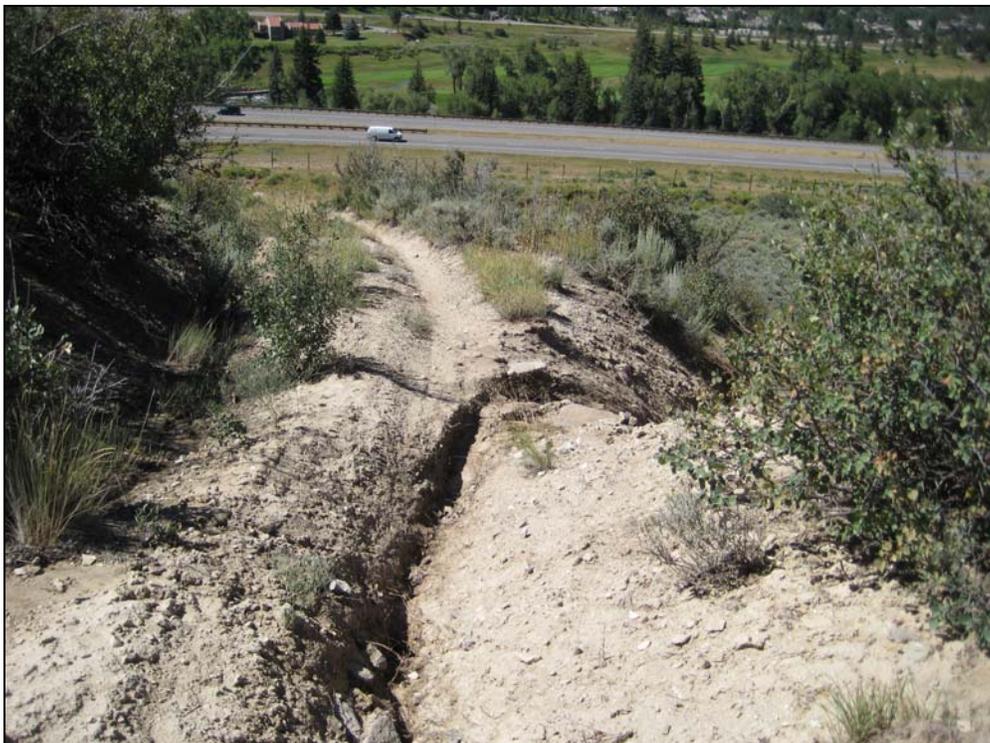
Looking south at a badly eroded and washed out section of the trail

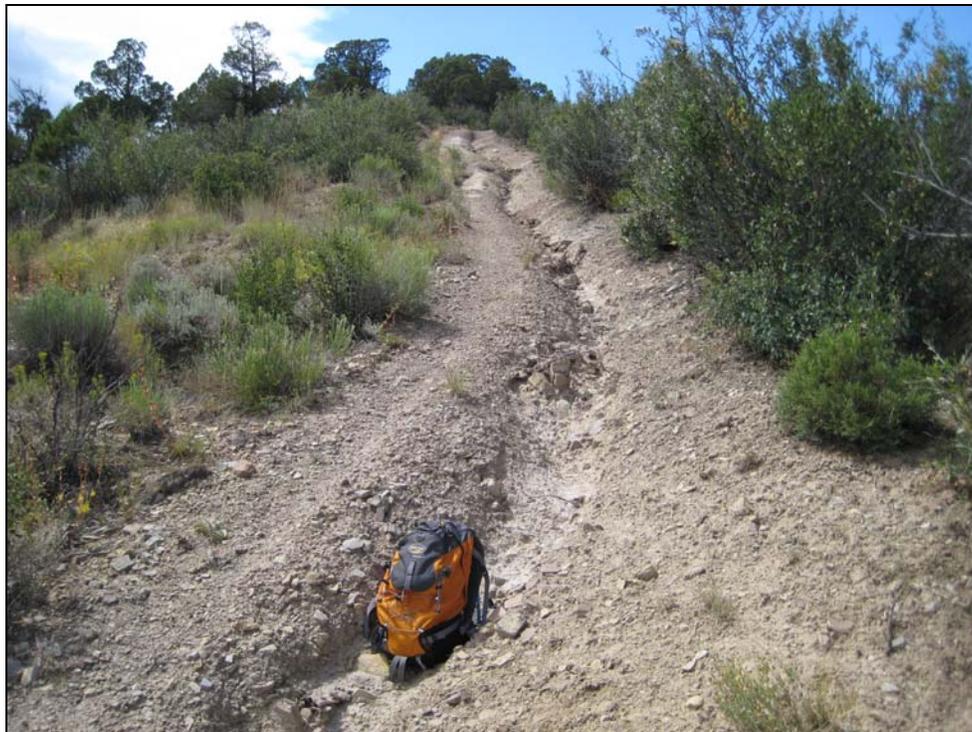
Looking northwest at one of the most eroded sections of the trail

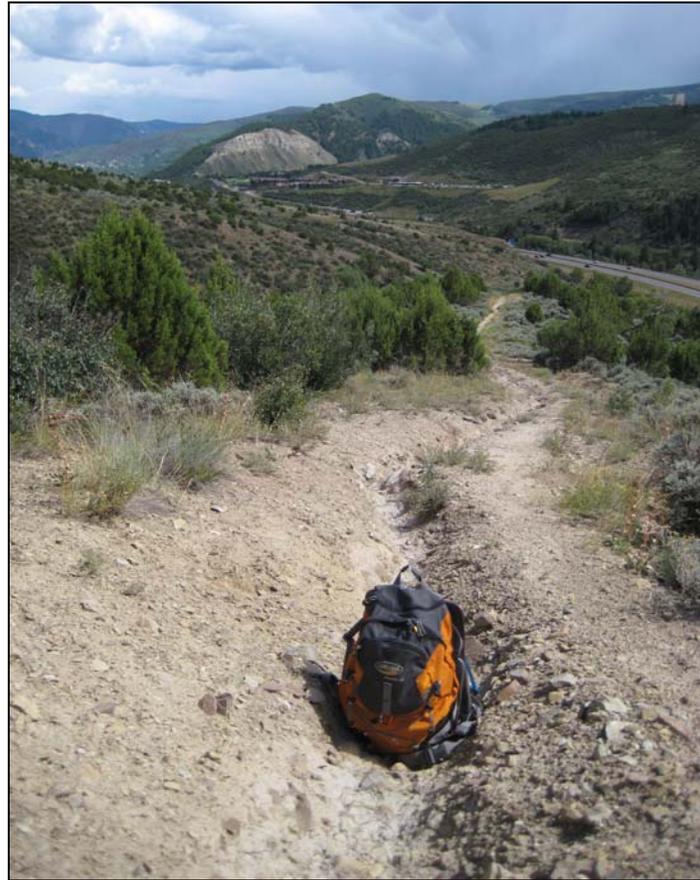
Looking southeast down the adjoining section of eroded trail as seen in the previous photo

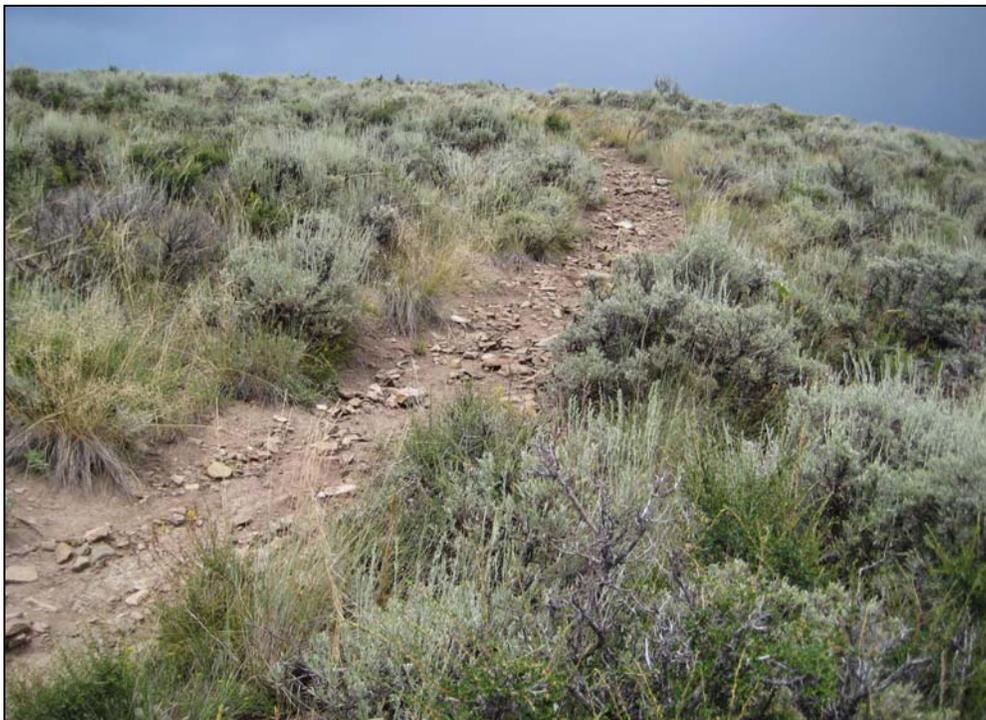
Looking north at an eroded section of the Saddle Ridge Trail just below its high point

Reconstruction of the trail beginning at the Saddle Ridge access point and eventually terminating at the junction of the Avon/Singletree Trail is recommended. Additionally a connector trail needs to be defined that connects to the Beaver Creek Lookout Trail (US Forest Service Decision Memo, April 2007). Two possible connector trails currently exist. However, the most sustainable option is proposed and the other is recommended for closure as depicted on map #3 in Appendix A. Approximately one-quarter mile of the Saddle Ridge Trail and one-quarter mile of the connector trail to Beaver Creek Lookout Trail should be reconstructed to begin the process of trail stabilization. Reconstruction of this trail should be performed by an experienced professional trail builder to ensure a sustainable outcome as the topography presents significant challenges. At minimum, when reconstructing the trail, specifications and principles for sustainable shared-use trail construction and maintenance should be implemented. Also, some of the adjacent social trails should be closed and reclaimed as depicted on map #3 in Appendix A. Reclamation will entail breaking up compacted soil manually or mechanically to regain soil porosity followed by revegetation of the area with native grasses and shrubs. It is recommended that the trail be adequately signed. At minimum, depending on priorities and availability of funding, the process of trail reconstruction and closure and reclamation of social trails should occur biennially which should help resurrect the trail from poor condition over the next six to eight years. To help prioritize this cycle, work should begin from the Saddle Ridge access point and continue south as funding permits. Table 7 on the following page presents the capital improvement cost estimate for this project.

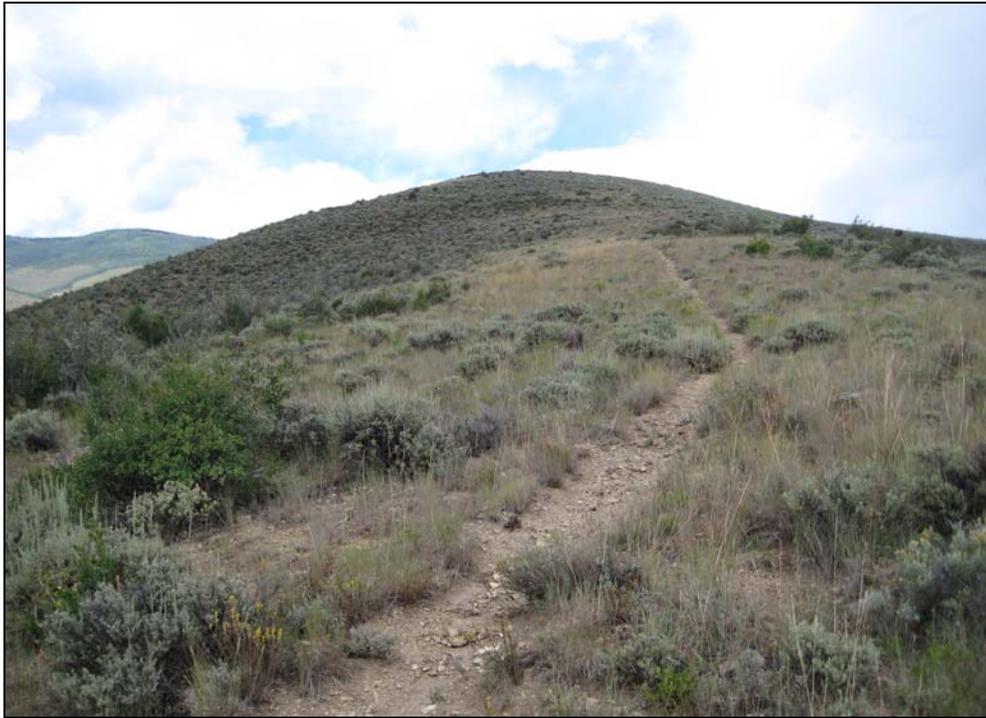
Looking north at the high point of the Saddle Ridge Trail along an eroded section

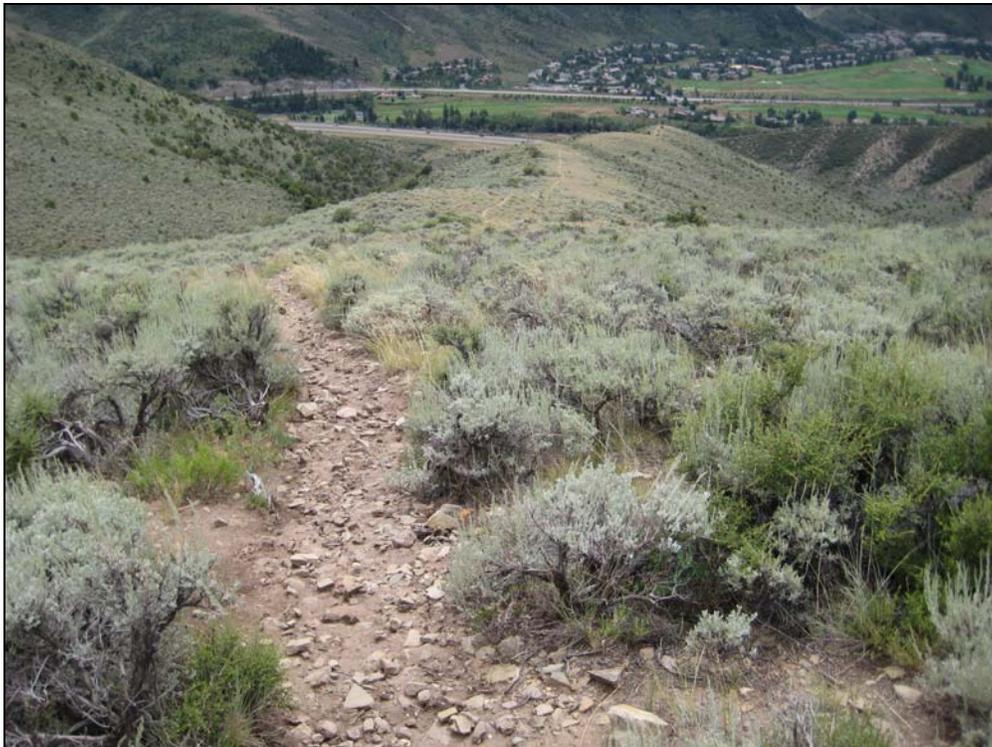
Looking south down an eroded section of the trail which follows the ridge line

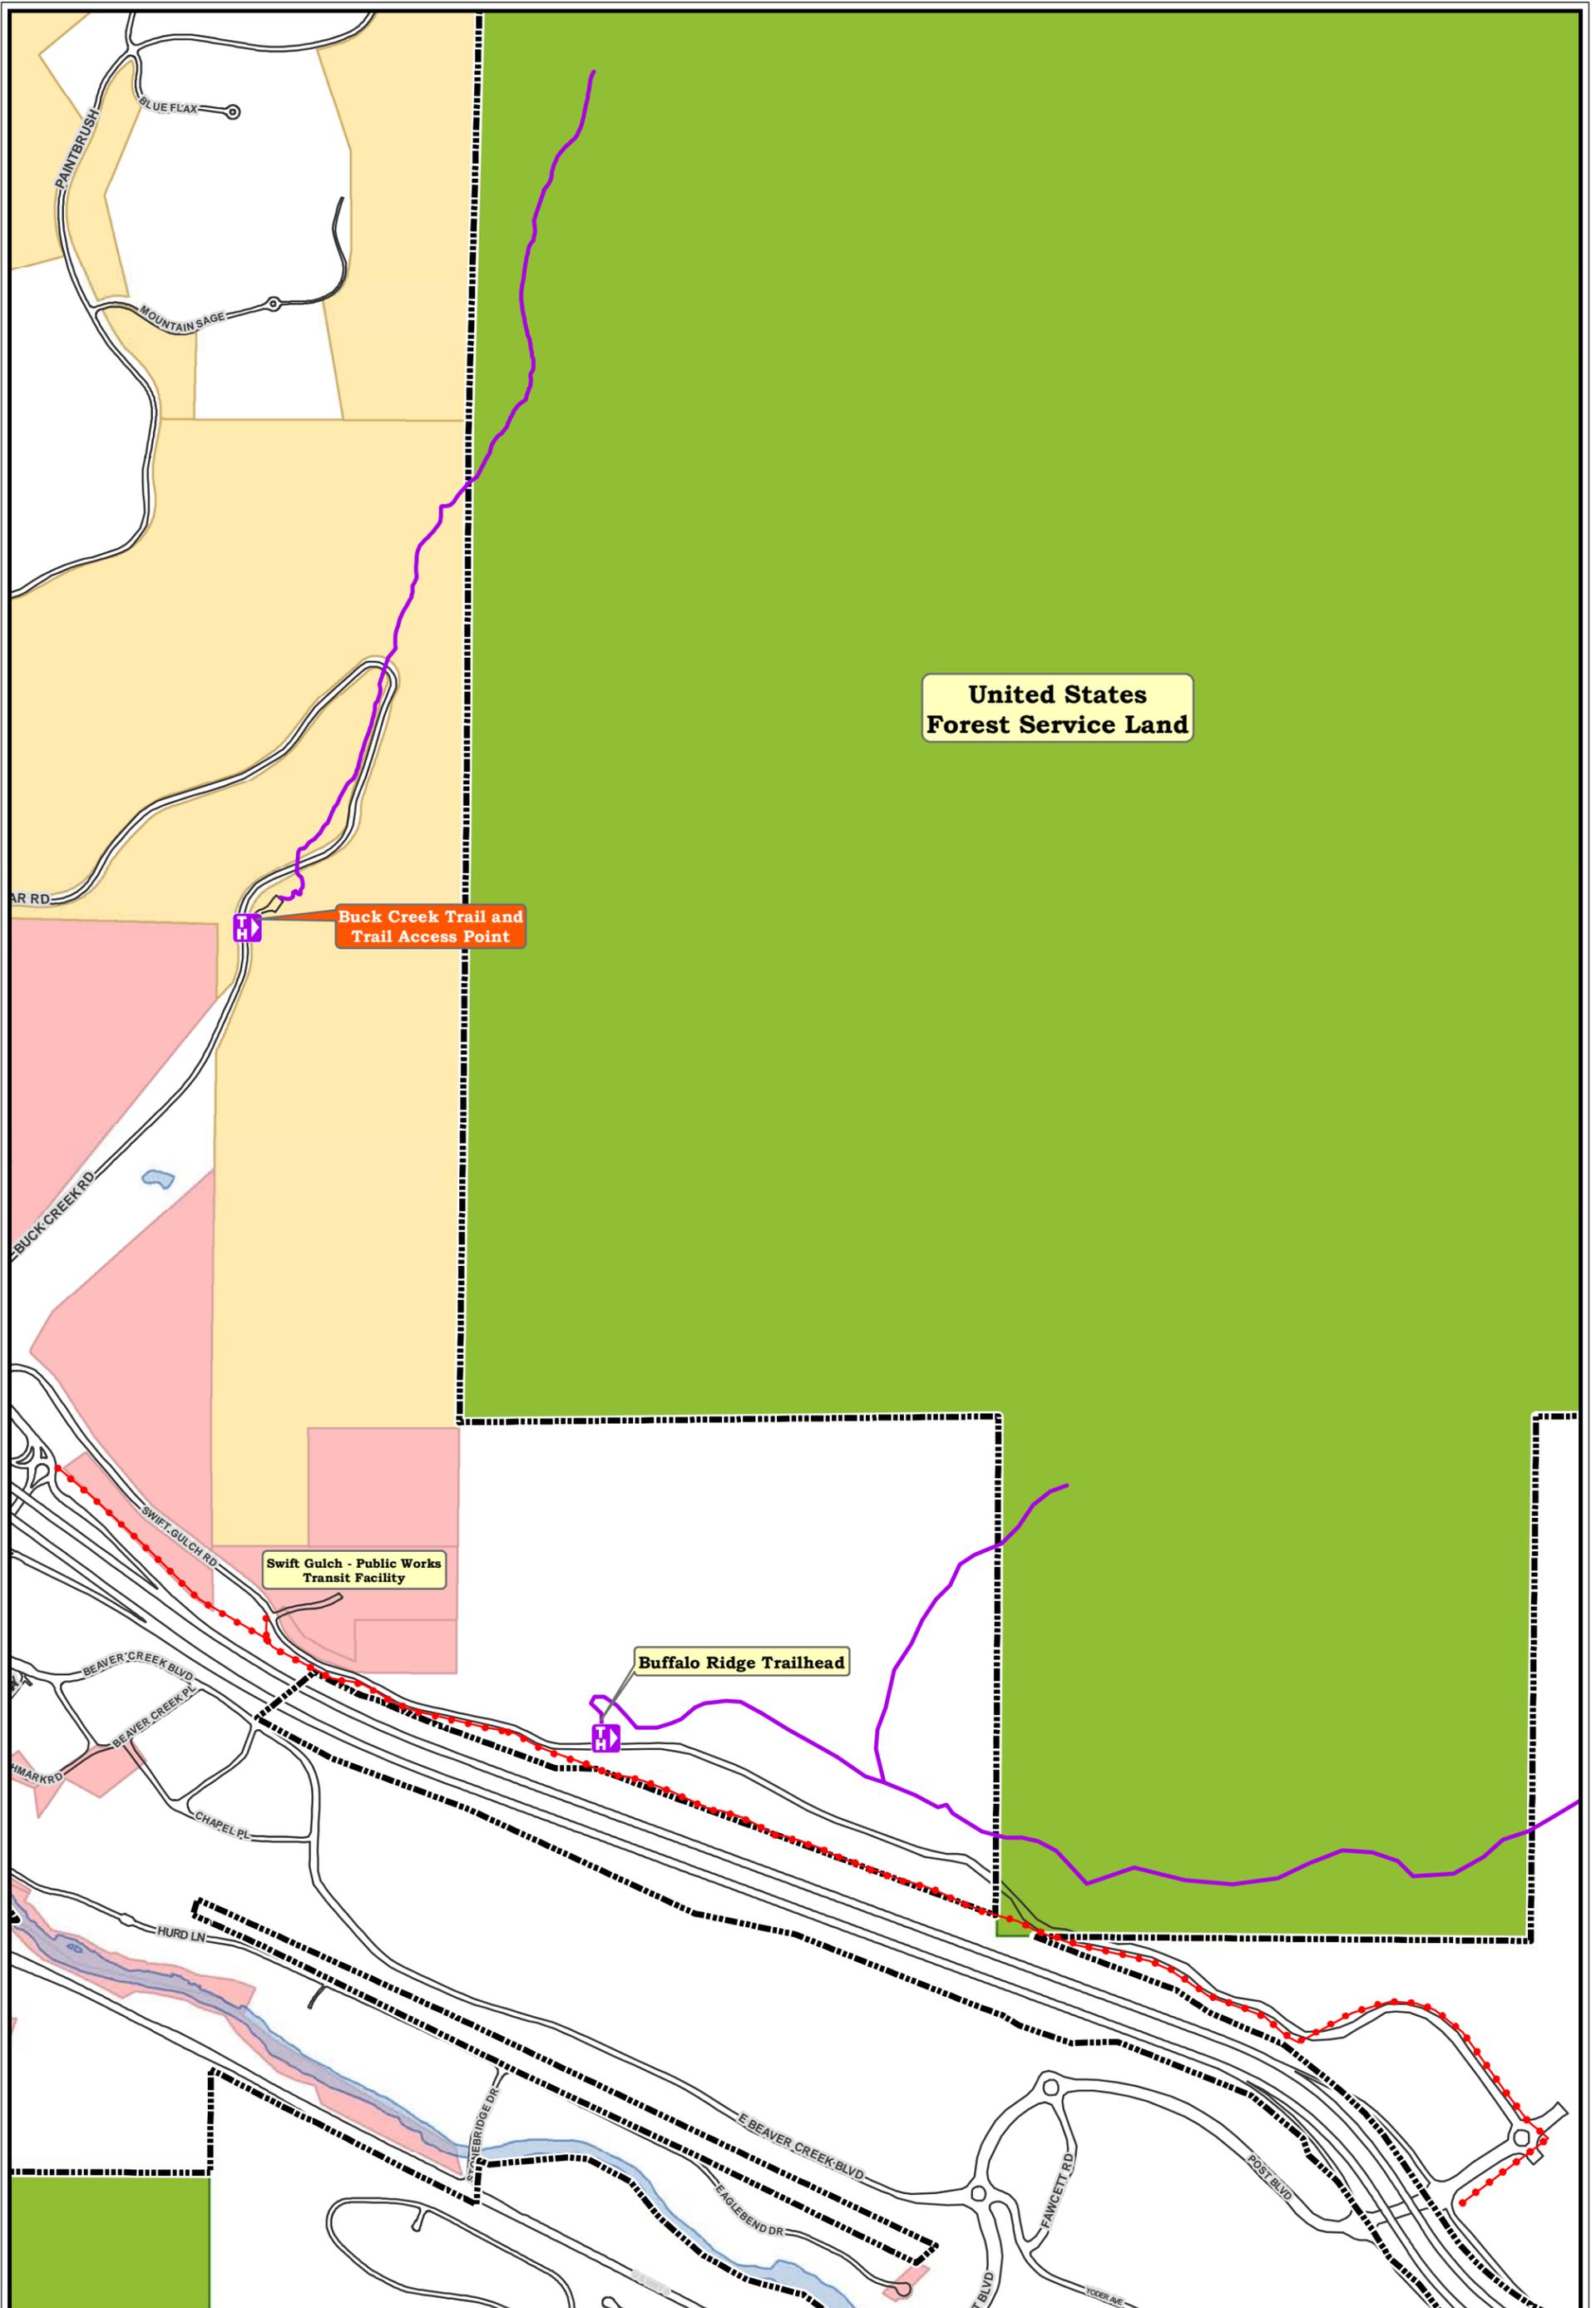
**Avon Trails Master Plan  
Recommended Program - East**

**Buck Creek Trail and  
Trail Access Point**
